# Property Inspection Report

**- Habit New Zealand Limited -**

***Sample Report. 1989 Weatherboard town house.***

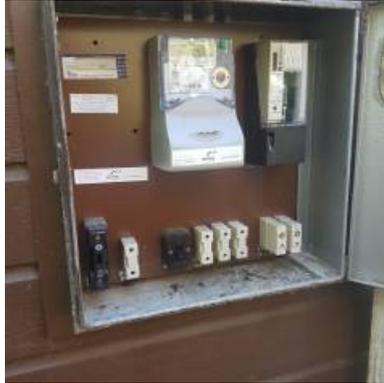
Older style fuses are found here. Due to the age and condition of the fuses we recommend a registered electrician further investigate as we do not conduct a full electrical inspection. If there are any faults this will be noted throughout the report.

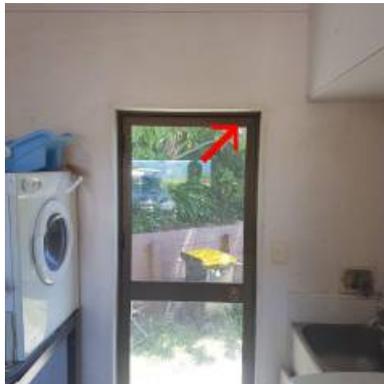
multiple, Hinged door, Remedial attention suggested, the exterior back door is not fitting well, it looks as though there has been some movement here. A joinery specialist is required to remedy this.

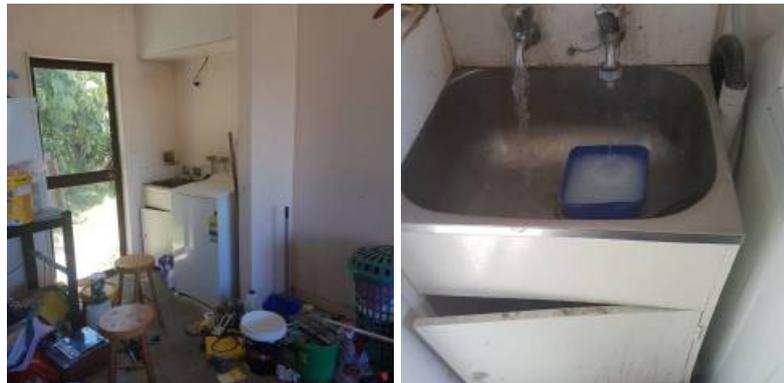
Laundry area, Super tub installed, **There is a leak in this area, water damage was viewed around and below the tub, further investigation by a registered plumber is required.**

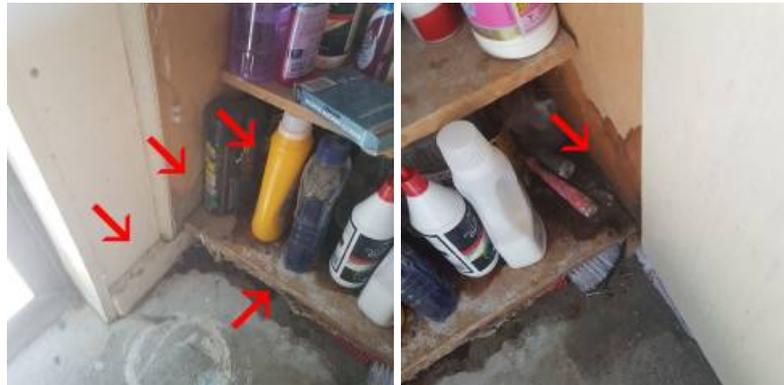
Relative moisture readings of concern were found in this area. Further investigation is required in this area, as this is only a non invasive inspection we cannot determine if there has been any damage caused to the wall framing.

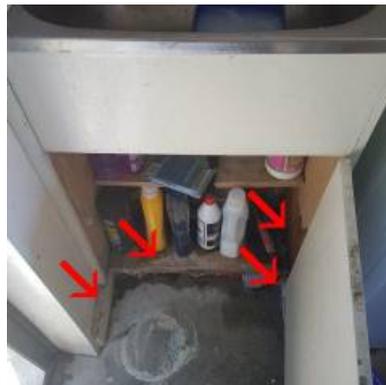
A current leak is evident.

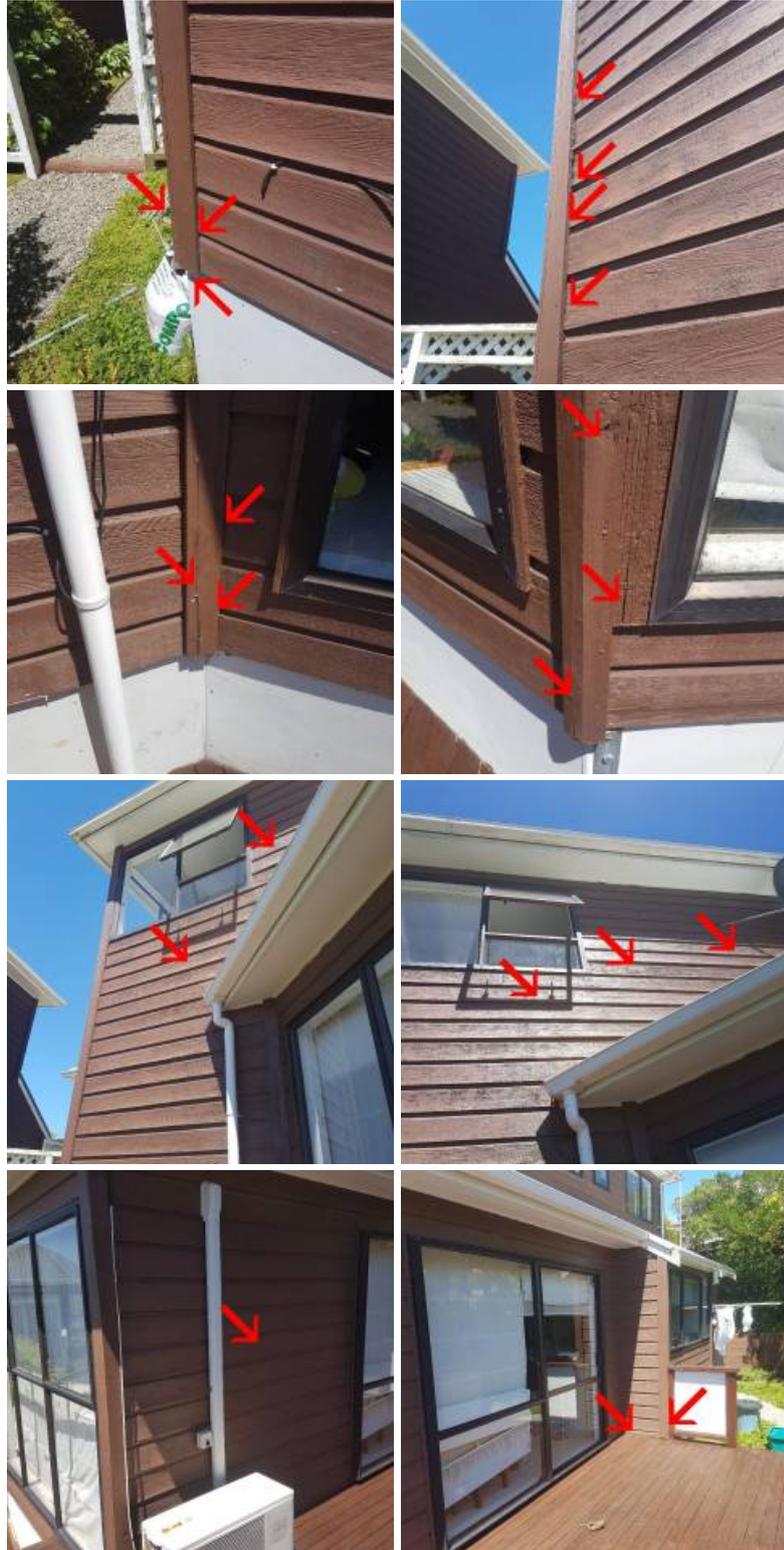
Weatherboard, Damaged and decayed wall cladding requires replacement by a licensed building practitioner. Cupped weatherboards to be re-fixed or replaced. Further investigation is required as the condition of the timber wall framing is not known, damaged may have been caused within the wall cavity that cannot be viewed on our non invasive inspection.

corners and facings to prevent any moisture ingress. These areas may have leaked in the past causing damage which cannot be viewed on our non invasive inspection. Further investigation required.

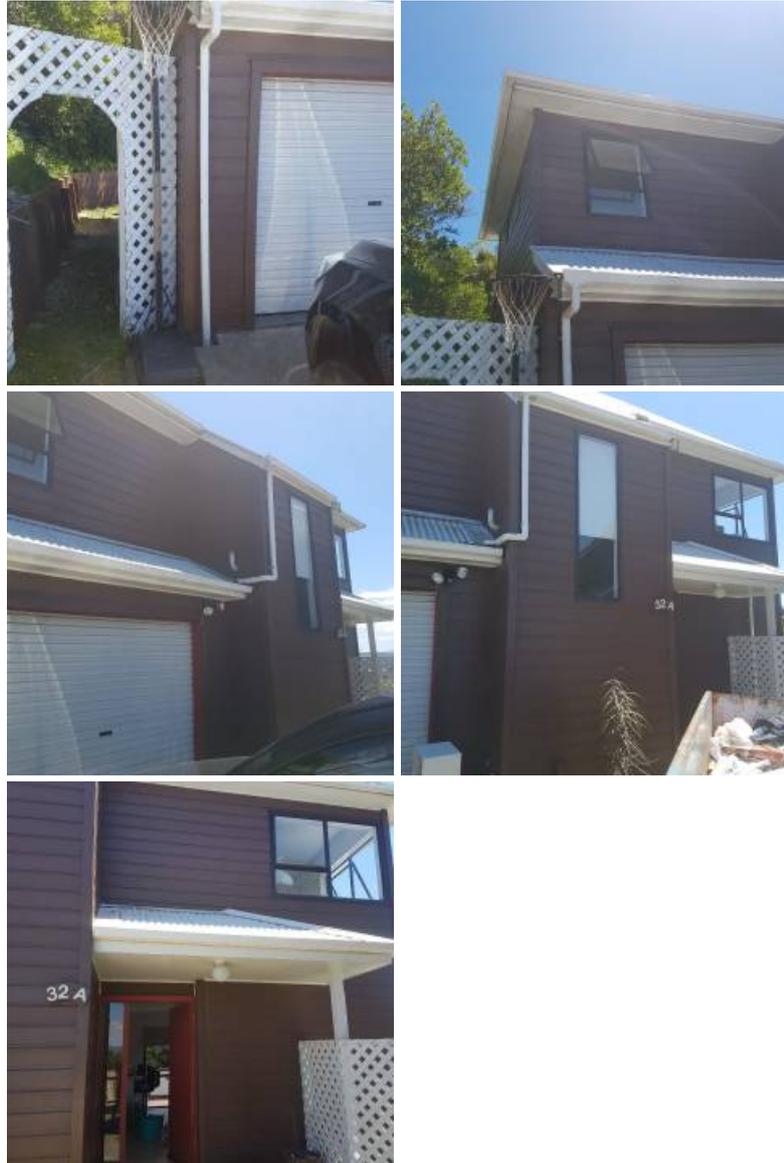
This area has been built hard up against the house and fixed directly through the cladding. This method of construction met the standards and regulations at the time of construction but is known to fail. This is a high risk design fault. This can cause damage to cladding, water can get trapped between the timber or other substrates and the cladding causing deterioration of both products. This can also allow water to track through the fixings into the building envelope. In turn this will cause moisture ingress into the dwelling causing damage to the wall framing and bottom plate. We strongly recommend that the area is packed off the cladding by 12mm and have rubber washers installed to prevent any moisture issues in the future. It is suggested that a Licensed Building Practitioner carry out this work. This area may have already leaked but we cannot determine if there is any damaged caused on our non invasive inspection. Further investigation is required.

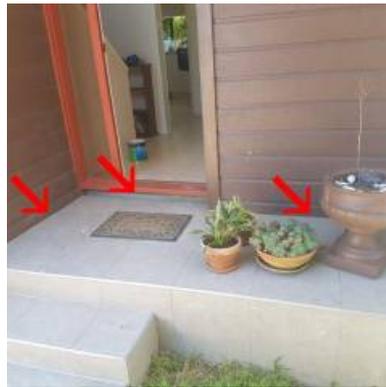
Insufficient ground clearance here, the clearance from the top of the finished ground height outside to the finished floor level inside, and to the bottom of the cladding is insufficient. This type of construction met the standards and regulations at the time of construction but is known to fail. This is a high risk design fault. This area has the potential to cause moisture ingress by capillary action when water sucks up between the wall cladding and framing. This area may have leaked in the past causing damage to the wall framing which cannot be viewed on our non invasive inspection. Further investigation is required. I suggest these ground heights are dropped and some form of drainage is installed to this area.

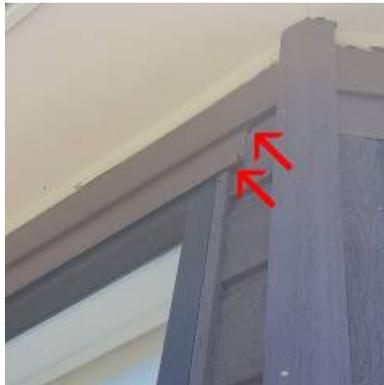
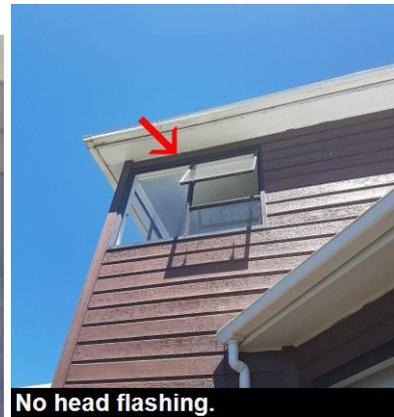
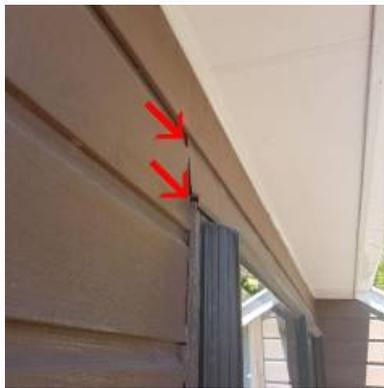
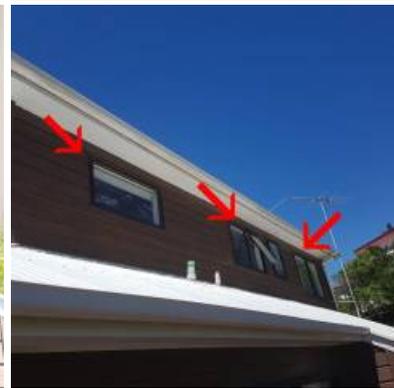
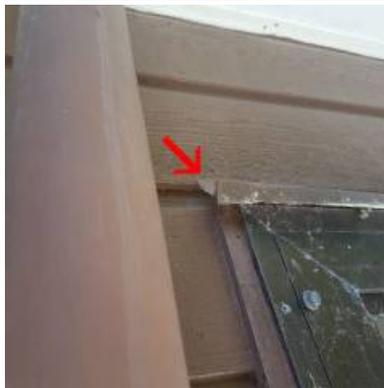
Remedial attention required. Head flashing required to be installed to all joinery which is missing flashings to ensure weather tightness. All loose or poorly fitted head flashings are to be replaced and or re-fixed and sealed. A licensed building practitioner can carry out this task. These areas are potential moisture risk points. These areas may have leaked in the past causing damage to the wall framing which cannot be viewed on our non invasive inspection. Further investigation is required.

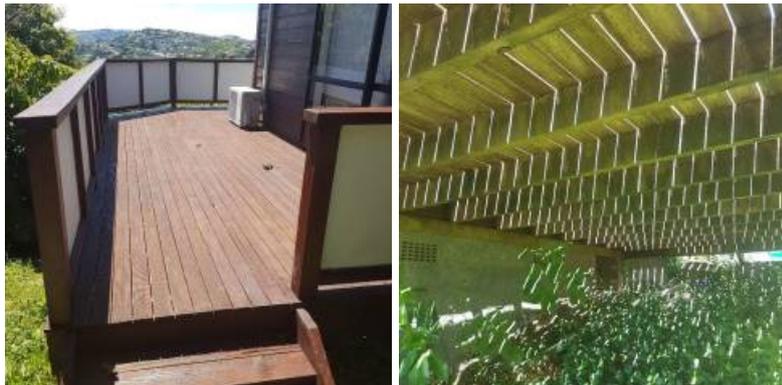
The deck has been built hard up against the house in this area. This type of construction met the standards and regulations at the time of construction but is known to fail. This can cause damage to cladding, water can get trapped between the timber or other substrates and the cladding causing deterioration of both products. This can also allow water to track through the fixings into the building envelope. In turn this will cause moisture ingress into the dwelling causing damage to the wall framing and bottom plate. We strongly recommend that the deck is packed off the cladding by 12mm and have rubber washers installed to prevent any moisture issues in the future. It is suggested that a Licensed Building Practitioner carries out this work. This area may have already leaked but we cannot determine if there is any damaged caused on our non invasive inspection. Further investigation is required.

damage to the wall framing and bottom plate. We strongly recommend that the deck is packed off the cladding by 12mm and have rubber washers installed to prevent any moisture issues in the future. It is suggested that a Licensed Building Practitioner carries out this work. This area may have already leaked but we cannot determine if there is any damaged caused on our non invasive inspection. Further investigation is required.

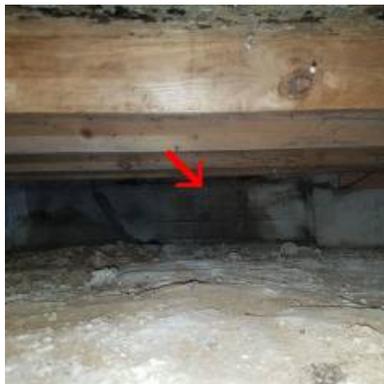
Water leaking into the subfloor area from the laundry tub, further investigation is required by a registered plumber.

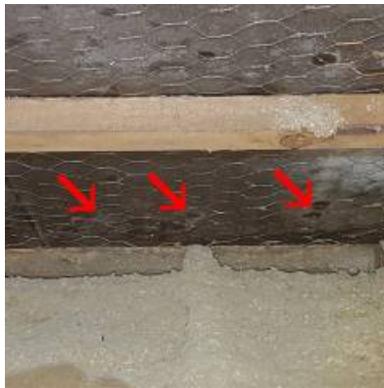
Damaged lining paper and rusted wire roof mesh was viewed in the roof space. There may be leaking. The roofing material requires further investigation by a licensed roofer to give you the right advice on the degree of replacement, upgrades and costings.
