# Property Inspection Report

**- Habit New Zealand Limited -**

***Sample Report. 1989 Weatherboard town house.***

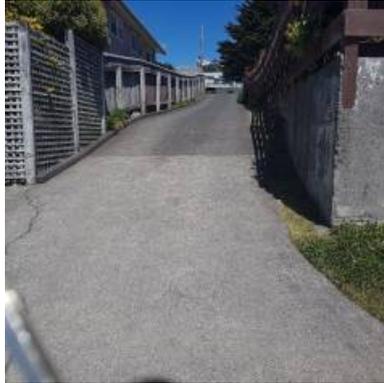
*Driveway:* Concrete, Shared, Good condition.

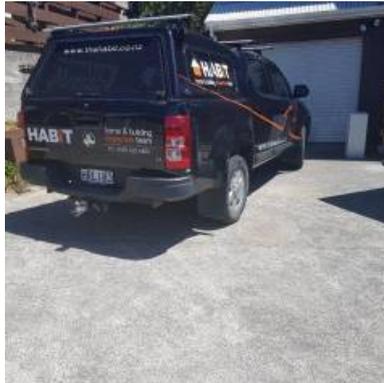
*Parking areas:* Concrete, Good condition.

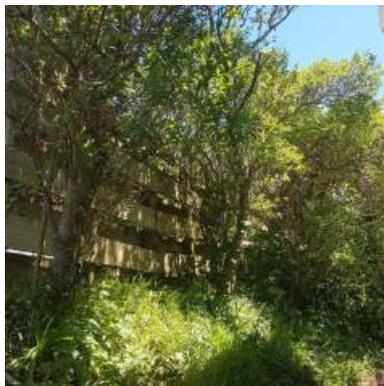
*Fencing General:* Timber Fencing material in: Reasonable Condition.

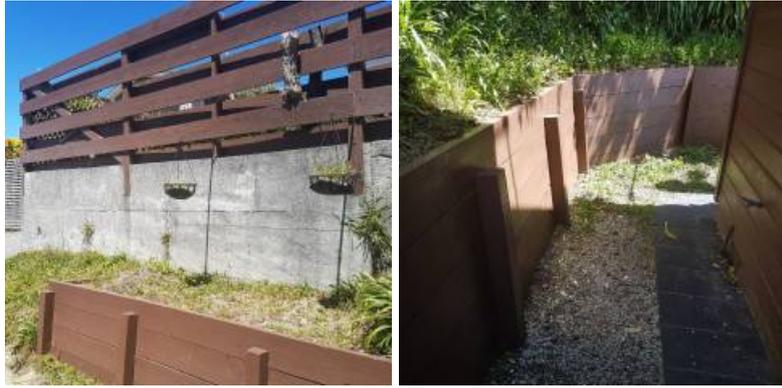
*Retaining Walls:* Concrete, Reasonably secured, ageing, and minor deterioration evident. Not of a structural concern. Some cracking evident.

Timber, Secured in a professional manner, Good Condition.

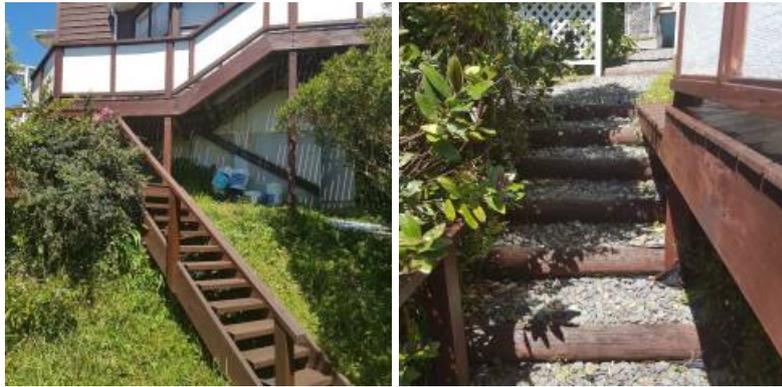
Timber, Handrail fitted, Reasonable Condition.

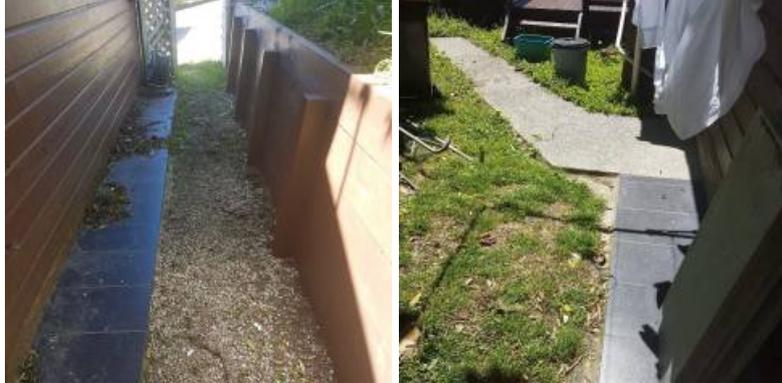
Tiles and concrete reasonable condition.

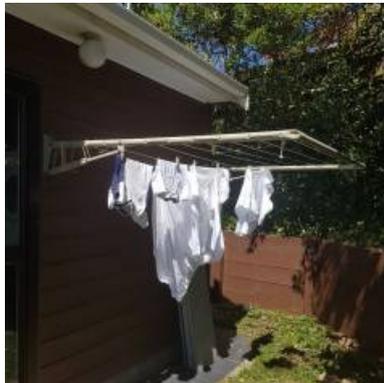
Fold Away clothesline is installed here. Good Condition.

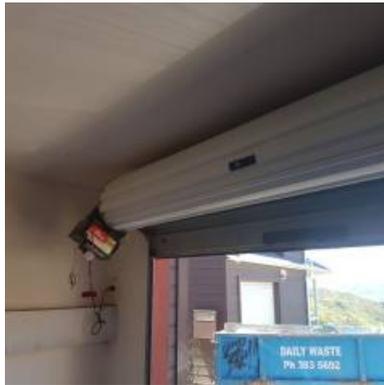
1 Automatic Roller, Reasonable Condition.

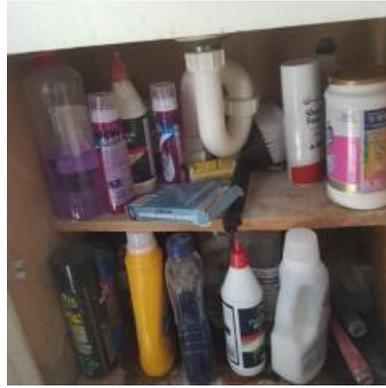
Relative moisture readings of concern were found in this area. Further investigation is required in this area, as this is only a non invasive inspection we cannot determine if there has been any damage caused to the wall framing.

A current leak is evident.

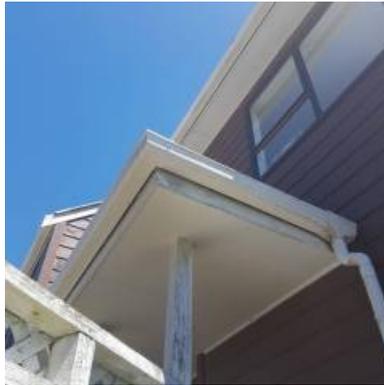
*Fascia:* Timber Fascia (includes barge boards if fitted), Material in, Reasonable Condition, Remedial attention suggested, Cosmetic upgrade required.

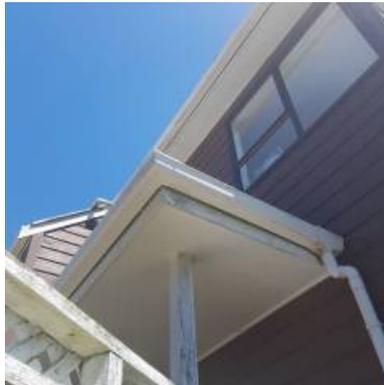
*Eaves:* The eaves may or may not be asbestos, refer to main summery (please read all comments)

Paint compressed fiber cement, Material in, Reasonable Condition.

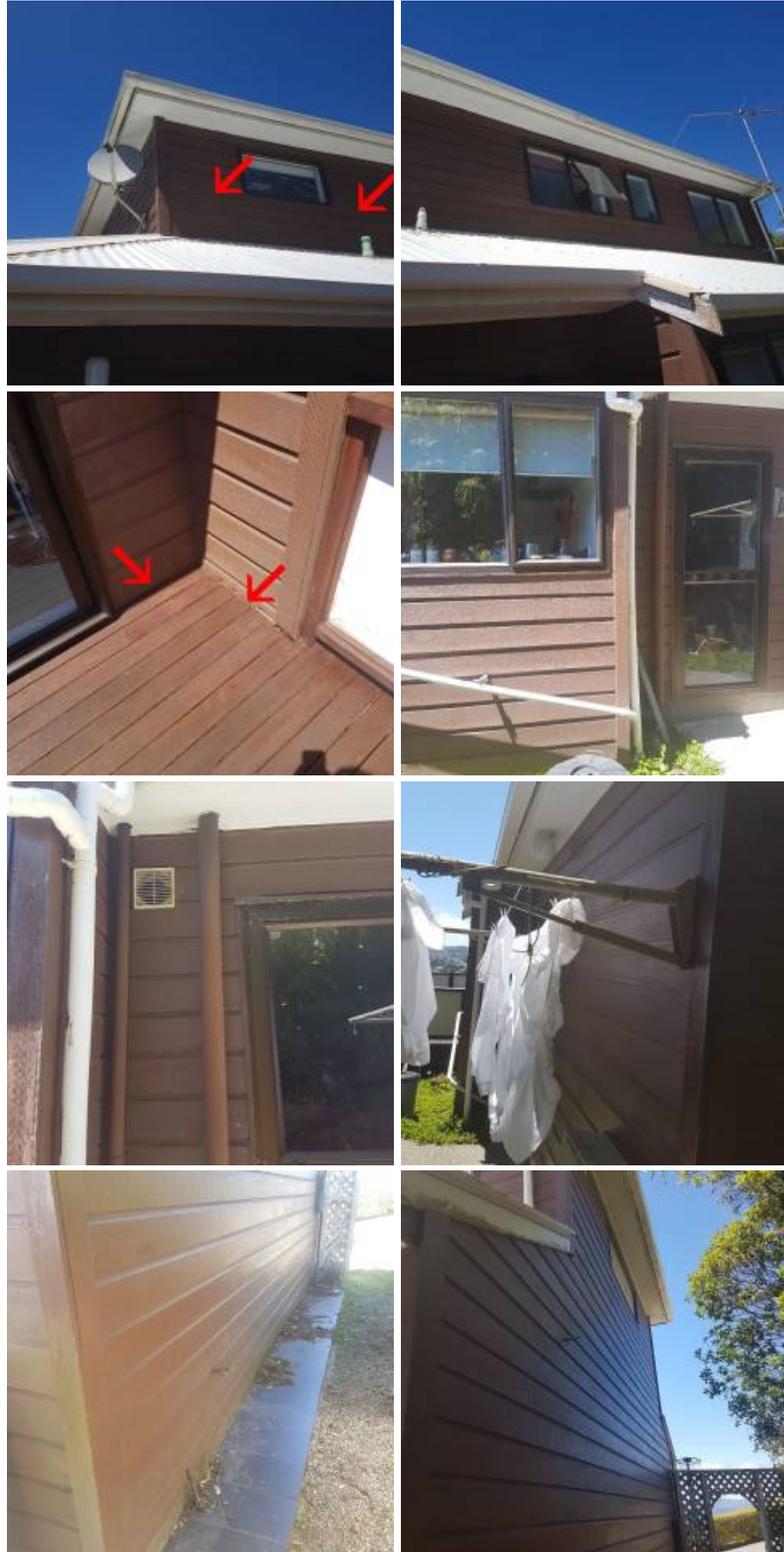
Missing timber rusticated plugs down the sides of all joinery and boxed corners are required to be fitted. These areas have leaked in the past, there is evidence of timber decay to some areas of cladding also. Further investigation is required as the condition of the timber framing is not known, damaged may have been caused within the wall cavity that cannot be viewed on our non invasive inspection.

Weatherboard, Damaged and decayed wall cladding requires replacement by a licensed building practitioner. Cupped weatherboards to be re-fixed or replaced. Further investigation is required as the condition of the timber wall framing is not known, damaged may have been caused within the wall cavity that cannot be viewed on our non invasive inspection.

corners and facings to prevent any moisture ingress. These areas may have leaked in the past causing damage which cannot be viewed on our non invasive inspection. Further investigation required.

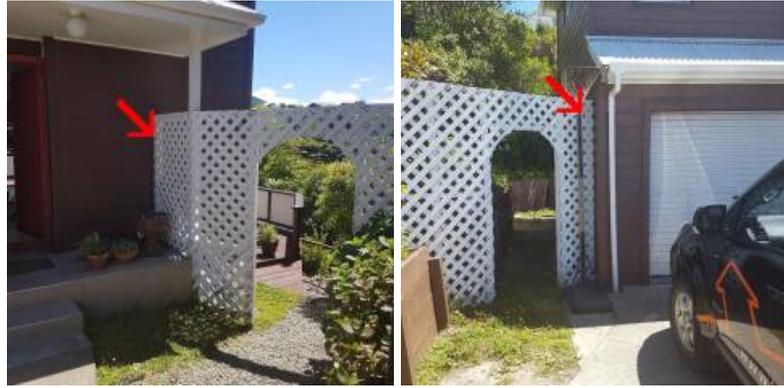
## Ground Clearances

Insufficient ground clearances at the front door area, the clearance from the top of the finished ground height outside to the finished floor level inside, and to the bottom of the cladding is insufficient. This type of construction met the standards and regulations at the time of construction but is known to fail. This is a high risk design fault. This area has the potential to cause moisture ingress by capillary action when water sucks up between the wall cladding and framing. This area may have leaked in the past causing damage to the wall framing which cannot be viewed on our non invasive inspection. Further investigation is required. I suggest these ground heights are dropped and some form of drainage is installed to this area.

Insufficient ground clearance here, the clearance from the top of the finished ground height outside to the finished floor level inside, and to the bottom of the cladding is insufficient. This type of construction met the standards and regulations at the time of construction but is known to fail. This is a high risk design fault. This area has the potential to cause moisture ingress by capillary action when water sucks up between the wall cladding and framing. This area may have leaked in the past causing damage to the wall framing which cannot be viewed on our non invasive inspection. Further investigation is required. I suggest these ground heights are dropped and some form of drainage is installed to this area.

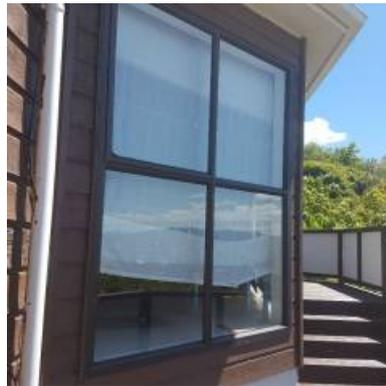
Aluminum, Material in, Reasonable Condition.

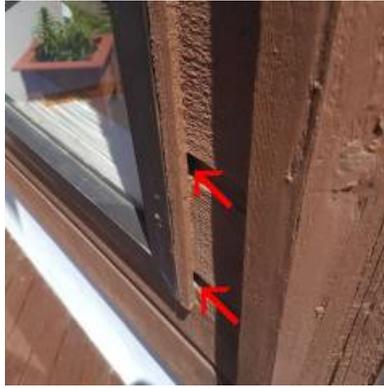
Poorly installed head flashings to joinery require replacement and or re-fitting, fixing and sealing. This area may have leaked in the past causing damage to the wall framing which cannot be seen on our visual non invasive inspection. Further investigation is required.

Remedial attention required, Timber chucks are required to be fitted down the sides of all joinery to prevent any moisture ingress. These areas may have leaked in the past causing damage to the wall framing which cannot be seen on our visual non invasive inspection. Further investigation is required.

Remedial attention required. Head flashing required to be installed to all joinery which is missing flashings to ensure weather tightness. All loose or poorly fitted head flashings are to be replaced and or re-fixed and sealed. A licensed building practitioner can carry out this task. These areas are potential moisture risk points. These areas may have leaked in the past causing damage to the wall framing which cannot be viewed on our non invasive inspection. Further investigation is required.

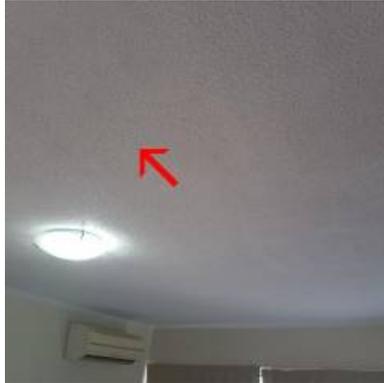
Base linings intact, [The texture coating may or may not be asbestos, refer to main summery \(please read all comments\)](#)  
Reasonable Condition.

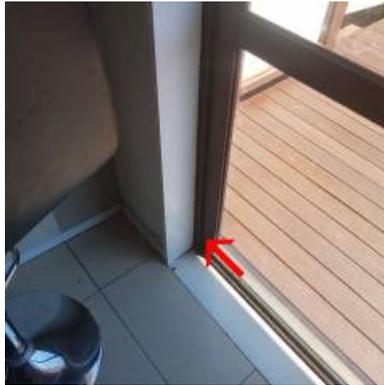
Sliding door, Functioning, [Remedial attention suggested](#), [Roller or Track adjustment required.](#)

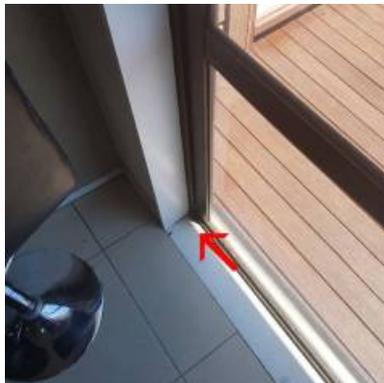
Base materials are in, [Remedial attention suggested](#), [Cosmetic upgrade suggested](#)  
[Damage evident](#), [Possible replacement of damaged area suggested.](#)

Be aware the door reveals in this dwelling are custom wood, this product swells when wet, such as condensation off the aluminium joinery, be sure to keep the sills well sealed and painted.

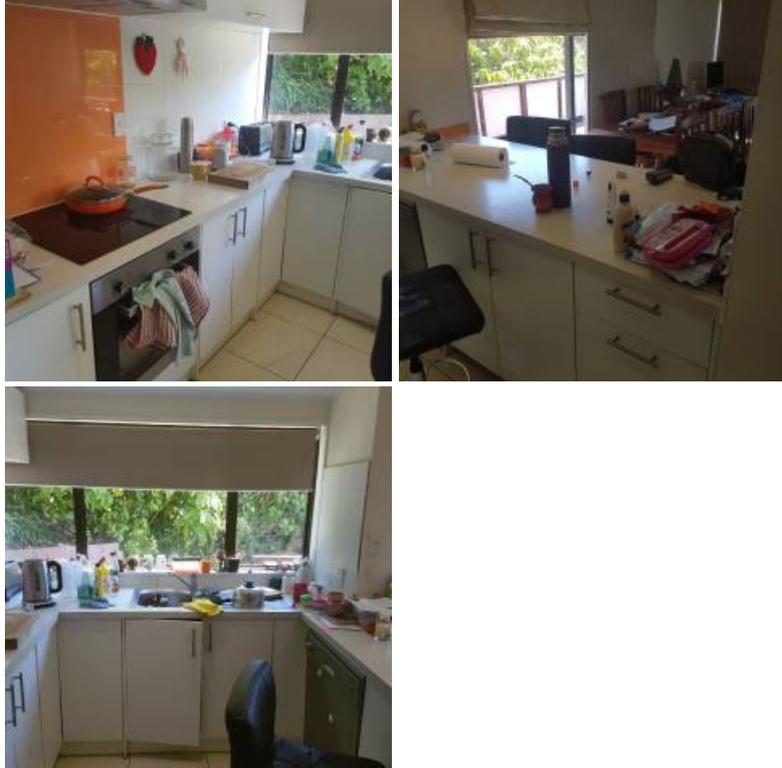
*Bench top:* Formica, Reasonable condition.

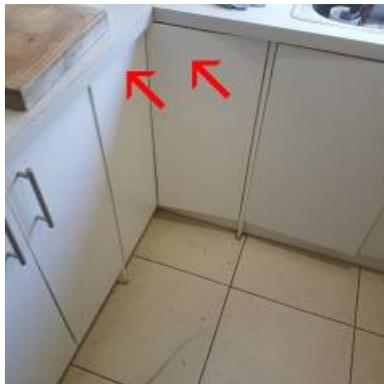
*Joinery Units:* Reasonable condition, functions adequately, [Remedial attention required. Handles required, all hinges require adjustment for doors to open and close freely.](#)

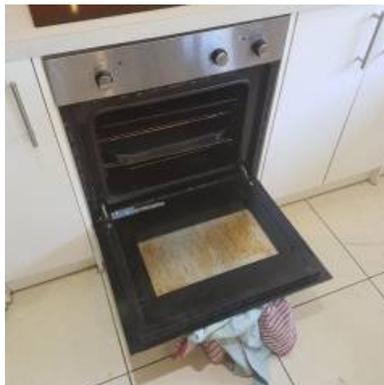
Modern conventional type, Under bench model, Tested, working. [Be aware thermostats are not checked. This is a specialised inspection which we do not carry out. We simply check if the oven heats up or not.](#) Reasonable condition.

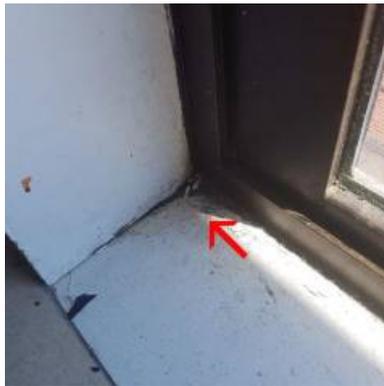
Historical moisture signs evident but no moisture readings of concern were found in this area on the day of inspection. As this is only a non invasive inspection we cannot determine if there has been any damage caused to the framing. Further investigation is required.

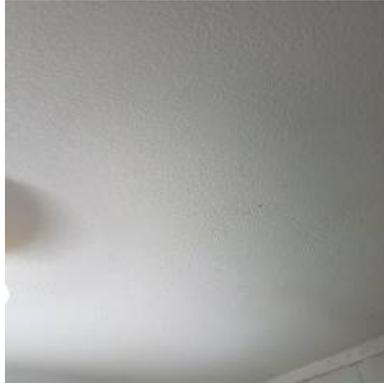
Base linings intact, [The texture coating may or may not be asbestos, refer to main summery \(please read all comments\)](#)  
Reasonable Condition.

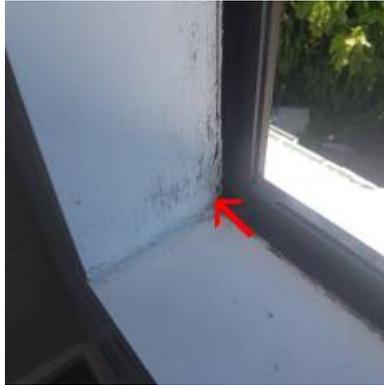
[Remedial attention suggested.](#) [Cosmetic upgrade required,](#) [Damage evident,](#) [possible replacement of damaged area suggested.](#) Be aware the window sills in this dwelling are custom wood, this product swells when wet, such as condensation off the aluminium joinery, be sure to keep the sills well sealed and painted.

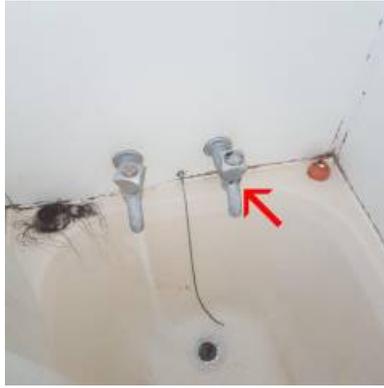
All wet areas were tested, a leak was found into the tub in the garage. The shower mixer is leaking and the cold tap to bath is not working.

2 single taps over the bath, Good water pressure. Cold tap not functioning.

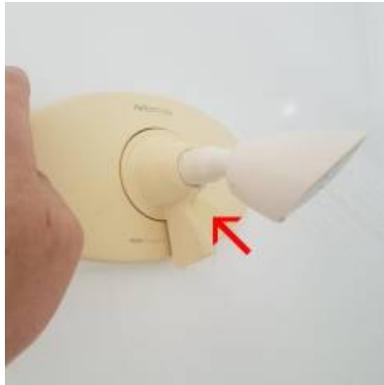
Single mixer, Good water pressure, Remedial attention suggested, Leaking water control evident.

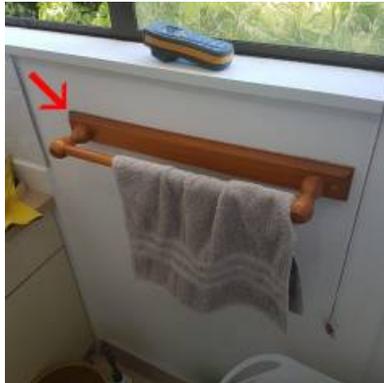
Towel rail, Re-fixing to wall required.

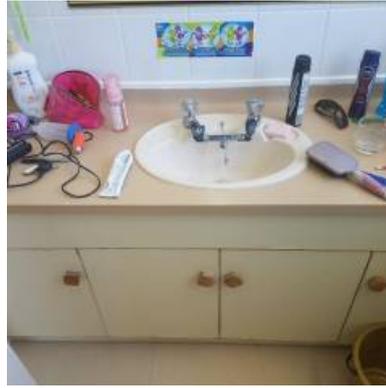
Flexi hose installed here. No plumbing running in the wall cavity was viewed, the plumbing product is unknown unless viewed in the subfloor or ceiling space and this will be noted on in their respective areas of the report.  
The waste pipe in this area is modern PVC.

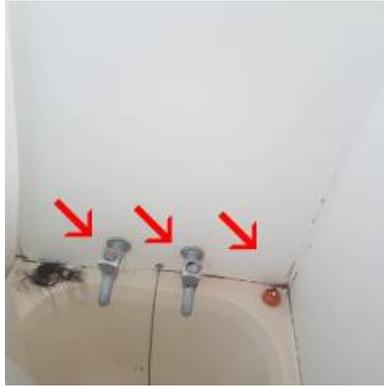
Relative moisture readings of concern were found in this area. Further investigation is required in this area, as this is only a non invasive inspection we cannot determine if there has been any damage caused to the wall framing.

*General Summary, and comments from the inspector on this area:* Reasonably well presented room. Linings intact. Minor remedial tasks if listed, generally cosmetic in nature. Signs of ageing, and wear. Remedial tasks as listed here are remedial tasks here that require immediate attention.

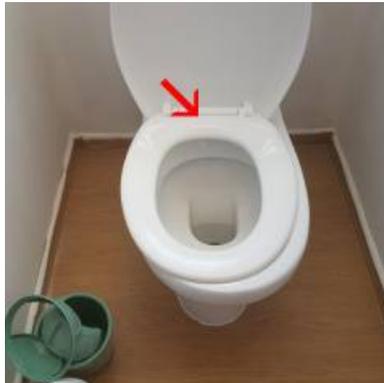
*Toilet Seat:* Plastic seat, **Requires Re-fixing.**

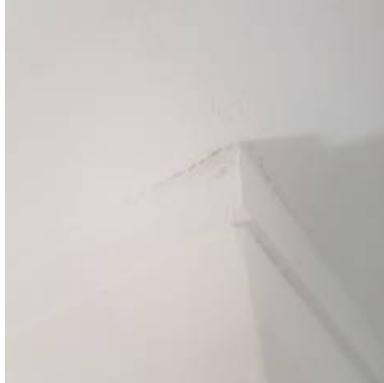
*Internal ceiling and wall linings:* Reasonable Condition. Area has been freshly painted not fully completed unpaintable sealant has been.

The texture coating may or may not be asbestos, refer to main summary (please read all comments) This has mostly been removed.

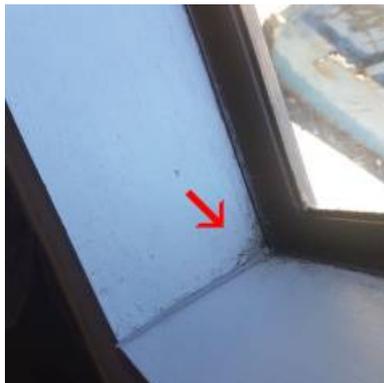
Remedial attention suggested. Cosmetic upgrade required, Be aware the window sills in this dwelling are custom wood, this product swells when wet, such as condensation off the aluminium joinery, be sure to keep the sills well sealed and painted.

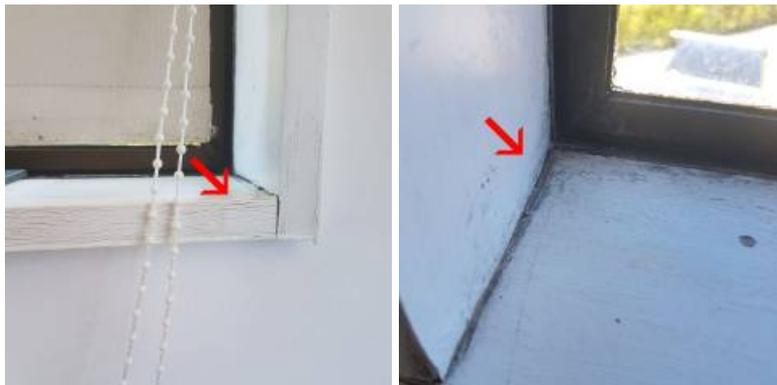
Remedial attention suggested. Cosmetic upgrade required, Damage evident, possible replacement of damaged area suggested. Be aware the window sills in this dwelling are custom wood, this product swells when wet, such as condensation off the aluminium joinery, be sure to keep the sills well sealed and painted.

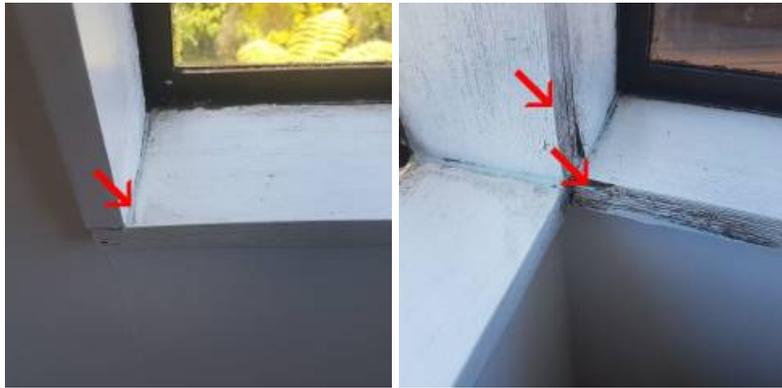
Remedial attention suggested. Cosmetic upgrade required, Damage evident, possible replacement of damaged area suggested. Be aware the window sills in this dwelling are custom wood, this product swells when wet, such as condensation off the aluminium joinery, be sure to keep the sills well sealed and painted.

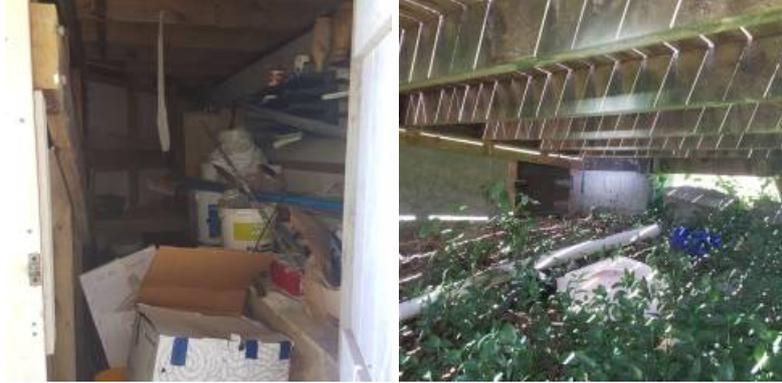
Poor access in to the sub floor area.

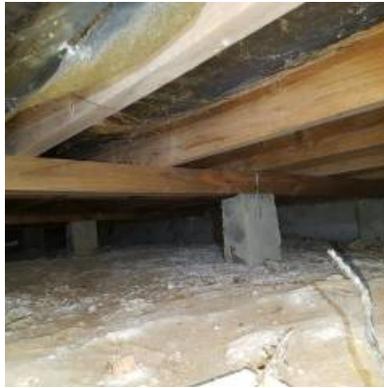
Water leaking into the subfloor area from the laundry tub, further investigation is required by a registered plumber.

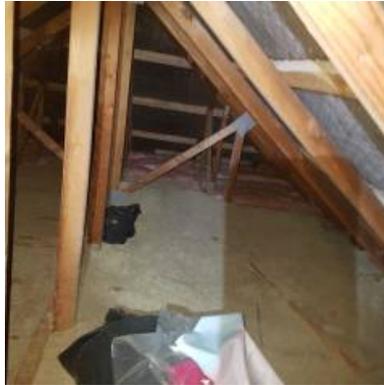
*Roof lining* Lining paper, Lining paper installed here is in a reasonable secure condition. Minor signs of ageing, or areas requiring minor re-fixing but no major issues here.

Holes noted on the bottom edge of paper, the roof may be leaking, The roofing material requires further investigation by a licensed roofer to give you the right advice on the degree or replacement, upgrades and costings.

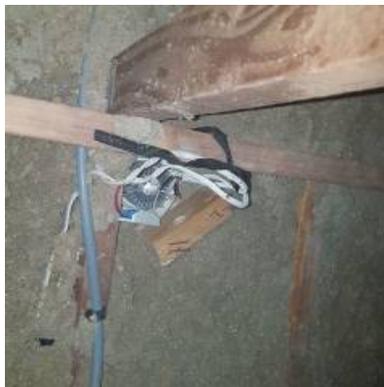
**Pest and debris here.** Rodent droppings were found in the ceiling space. We suggest this suggest this issue is attended to by either using poison or traps. It is hard to determine where the rodents may be entering the ceiling space so these two options will be your best to help eradicate this issue.

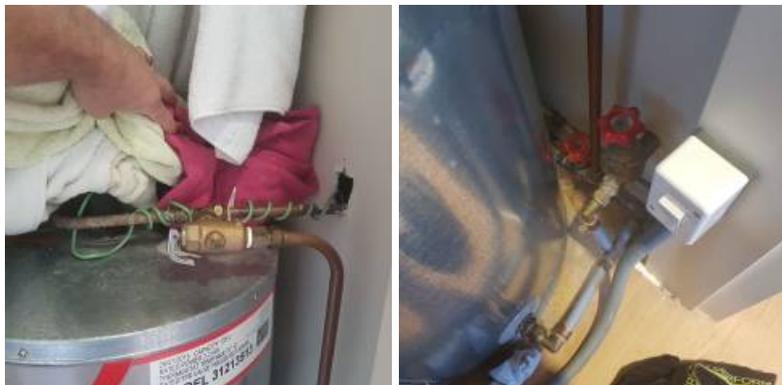
*Seismic Strap:* Seismic strap not fitted.
